<u>Green Well Westland</u>

HON-GT-01-S1

Blockage investigation

Prepared by:	WEP
Author:	Kornelius Boersma
Version:	1.4
Publication date:	26 March 2015
Agreed:	Maarten Middelburg, Henny Cornelissen, Dick Swart, Alexander Nagelhout

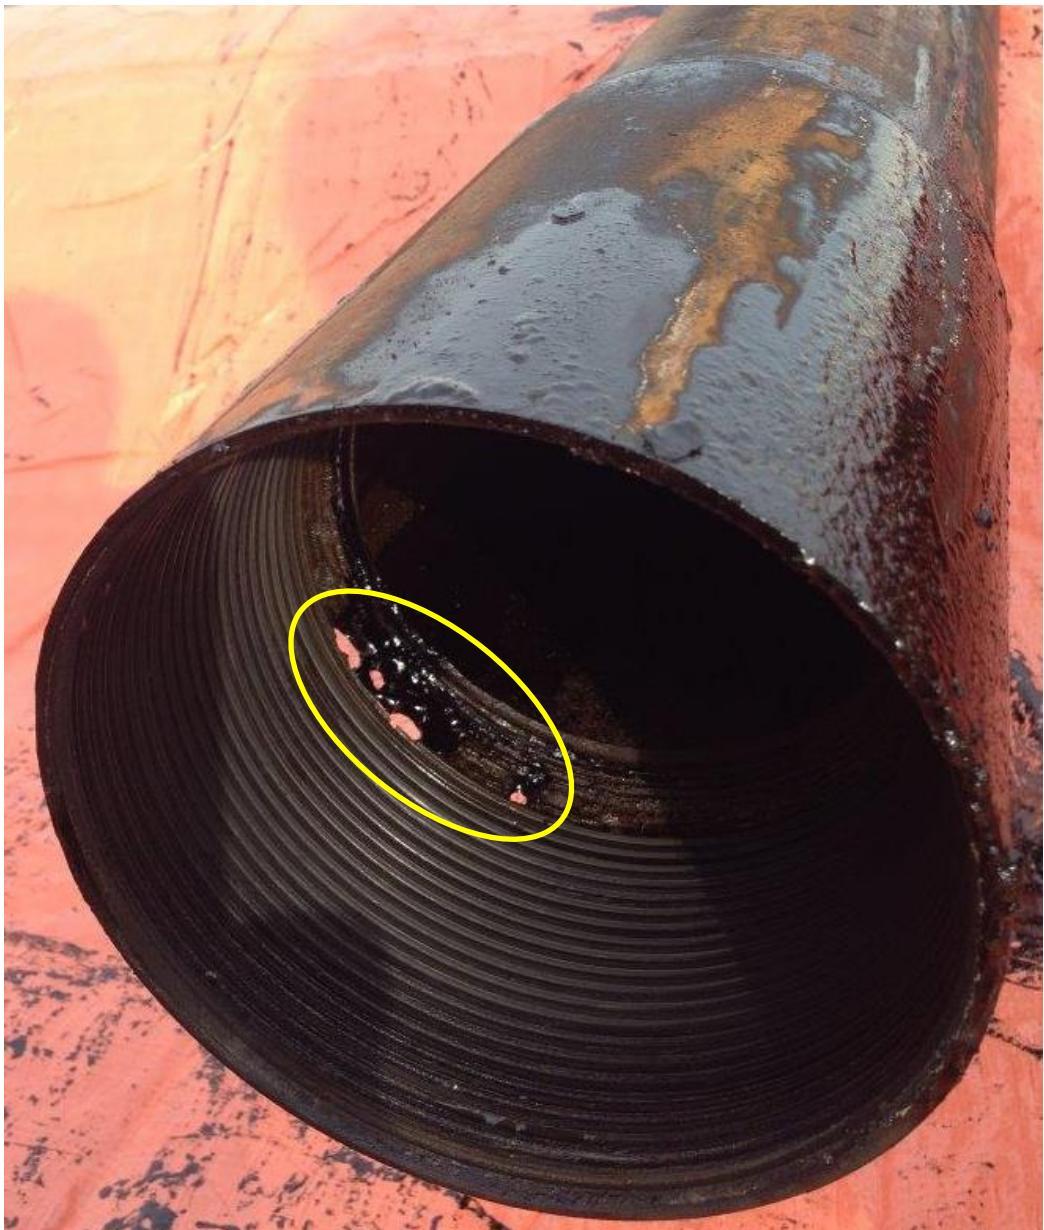
In 2013 the 6 %" production tubing was replaced after erosion-corrosion effects on the BTC couplings on the old tubing. The couplings showed small holes (see Figure 1). A study to the cause & solutions was performed by Technisches Büro Karl GOLLOB GmbH (1).

Figure 1: Damaged connection on production tubing 2013. Holes marked in yellow circle.

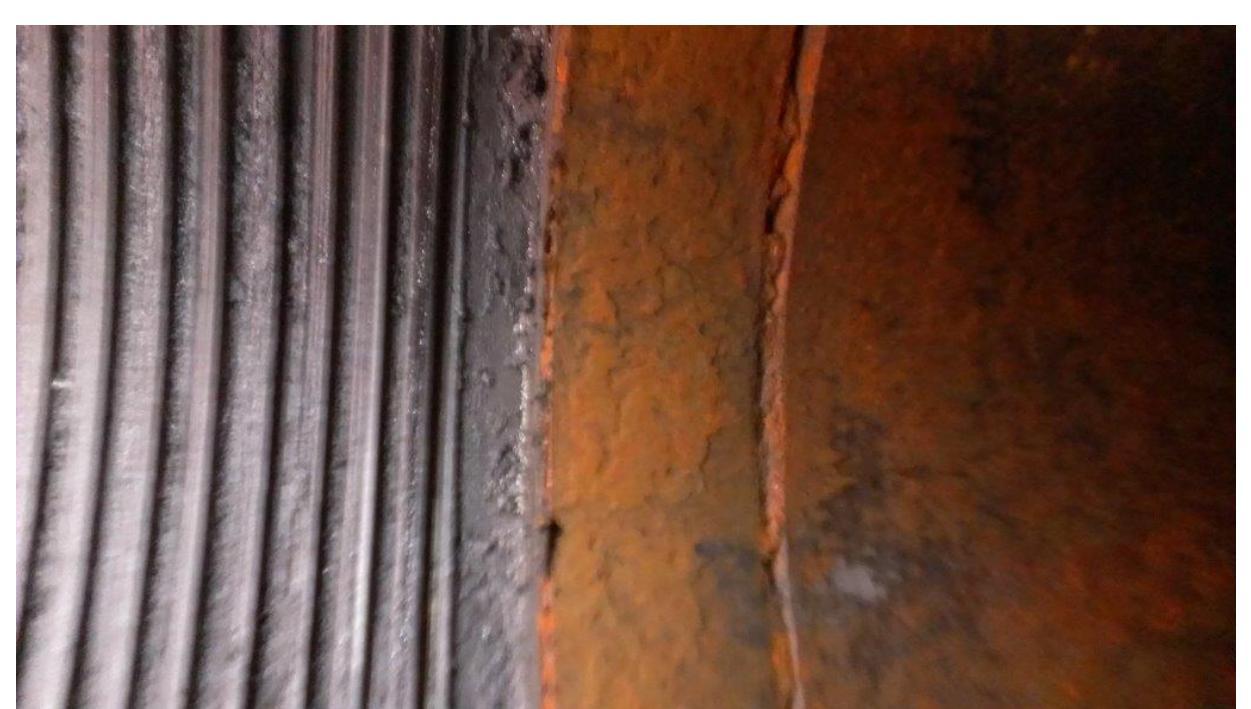
The new tubing had internal flush BTC SC couplings installed. After pulling the ESP no damage on any part of the ESP was reported. No damage was observed on the connections in the string; connections were 'as new'. See also Figure 2.

Figure 2: Inside of coupling on 2013 installed production tubing (picture taken on 19-11-2014)

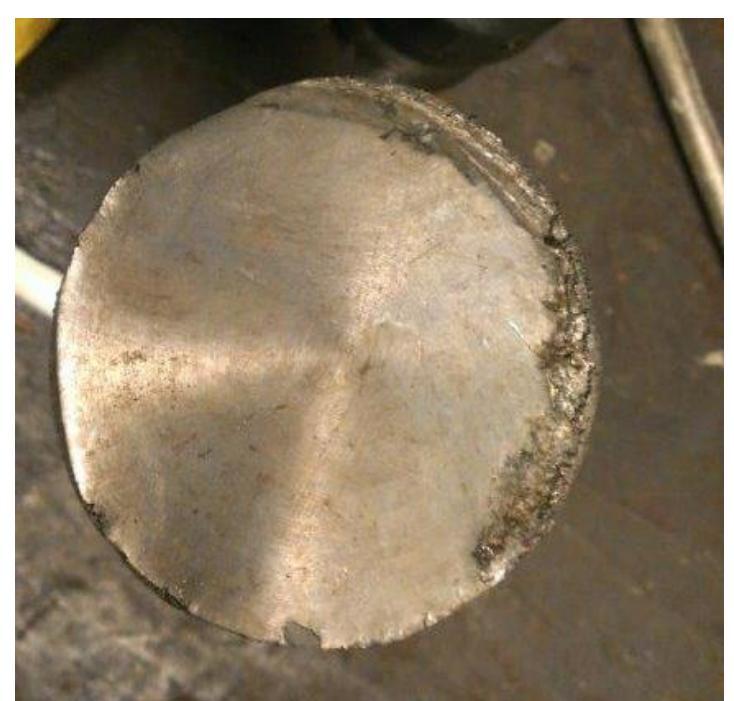
Figure 3: Impression of TOL @ 2397m on 1st LIB run with 3,75" LIB

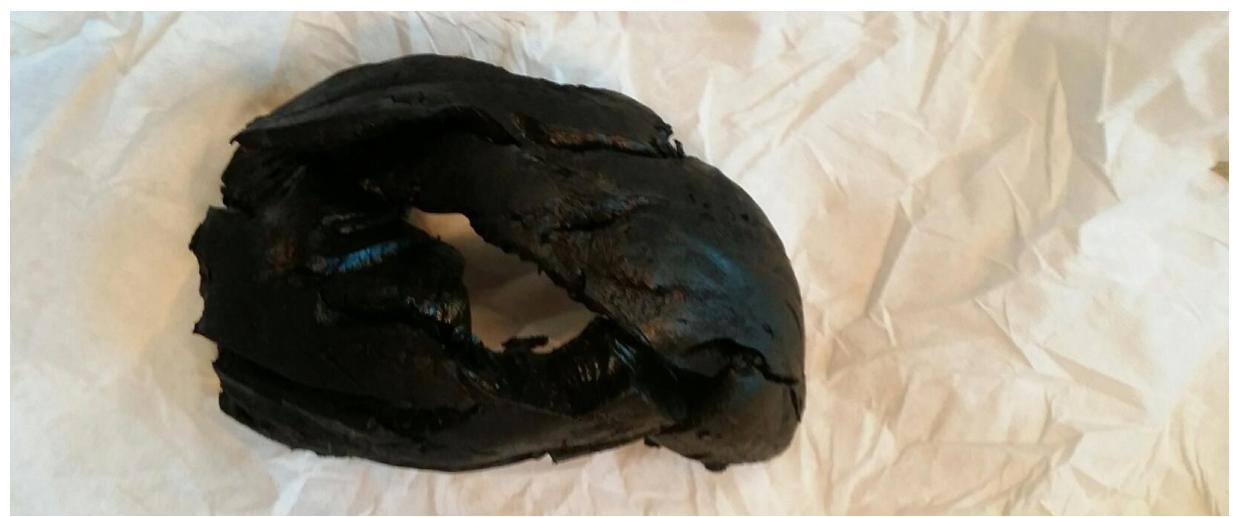
- 3,5" bailer to 2397m (empty)
- 3,5" bailer to 2422m
 - Found traces of stone + piece of rubber (Figure 4)
 - The origin of this rubber is not sure
 - Does not originate from the 4 ½" x 7" liner hanger (verbal by GOT)

Figure 4: Ca. 4" piece of rubber retrieved from HON-GT-01S1 from 2422m with bailer run

- Piece of rubber retrieved from 2422m
 - Not from liner hanger (verbal by GOT wrong colour, shape & hardness)
- Pieces of Rodenrijs Claystone formation have been found inside the 4 ¹/₂" liner
 - Claystone pieces (3cm) did not fit annular clearance 7" x 4 ½" liner
 Confirmed by tests on surface
- Damage on the liner would expose the 4 ¹/₂" x 7" annulus
 - o Injection tests showed plugged well, including annulus

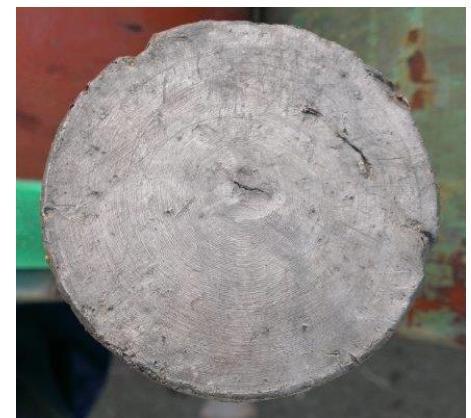
2,75" LIB. stood up at 2397m
 Showed no marks (Figure 5).

Figure 5: Result of second LIB run to 2397m with 2,75" LIB - no marks

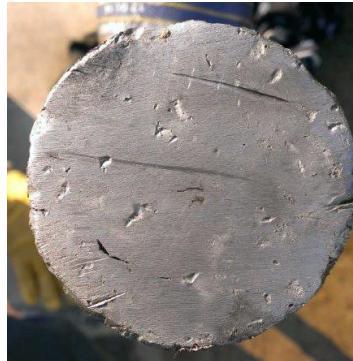
- Spear with 2,25" fluted centralizer. Stood up at 2422m.
 No overpull when POOH
- 2,25" LIB with 3,5" fluted centralizer to 2422m
 <u>Various small marks on LIB (Figure 6). Source undefined</u>

Figure 6: Result of third LIB run to 2422m with 2,25" LIB – various small marks

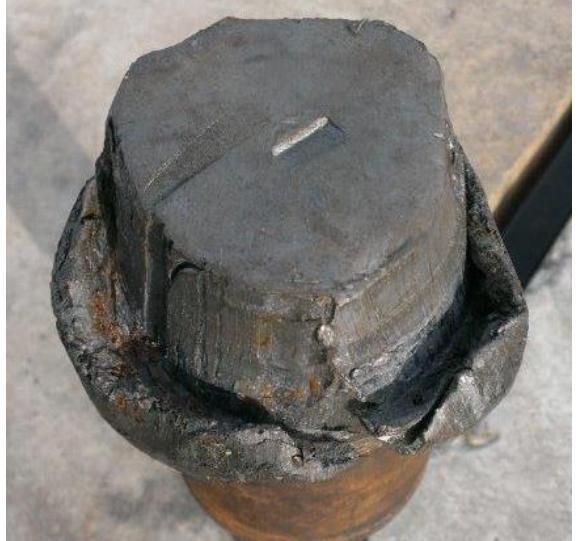
- 2,25" LIB with 3,5" fluted centralizer to 2422m
 - o No clear marks on bottom LIB
 - Lead on side of LIB stripped upwards by a tube shape possibly TOL

Figure 7: Result of fourth LIB run to 2422m with 2,25" LIB – lead stripped upwards by tubing or TOL

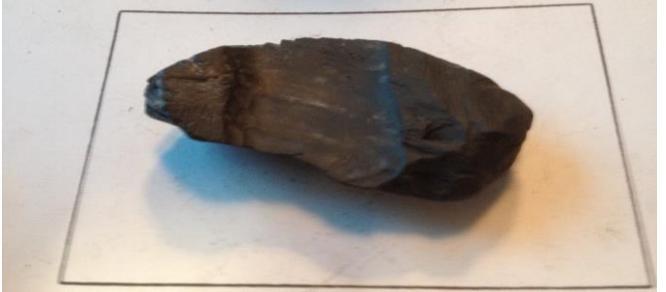
- 2,5" bailer stood up at 2397m
 - 1,75" bailer to 2422m. Jarred down 30 times
 - o POOH with 300 lbs overpull
 - o Retrieved half a cup stone, clay and iron debris from 2422m
 - The larger pieces were ca. 3cm in size. (see Figure 8).

Figure 8: Ca. 3cm claystone piece from HON-GT-01-S1 retrieved from 2422m with bailer run

The clay retrieved by the wireline bailer operations was analysed by PanTerra Geoconsultants (5). The clay sample was found to originate from the Rodenrijs Claystone, which was found between 2463 and 2560m (6). The microfossils found in the sample matched a sample as retrieved from well VDB-04. From this analogy the sample was allocated more precisely to the upper 30m of the Rodenrijs Claystone. Therefore it would come from approximately between the 7" casing shoe (2470m) and 2500m MD.

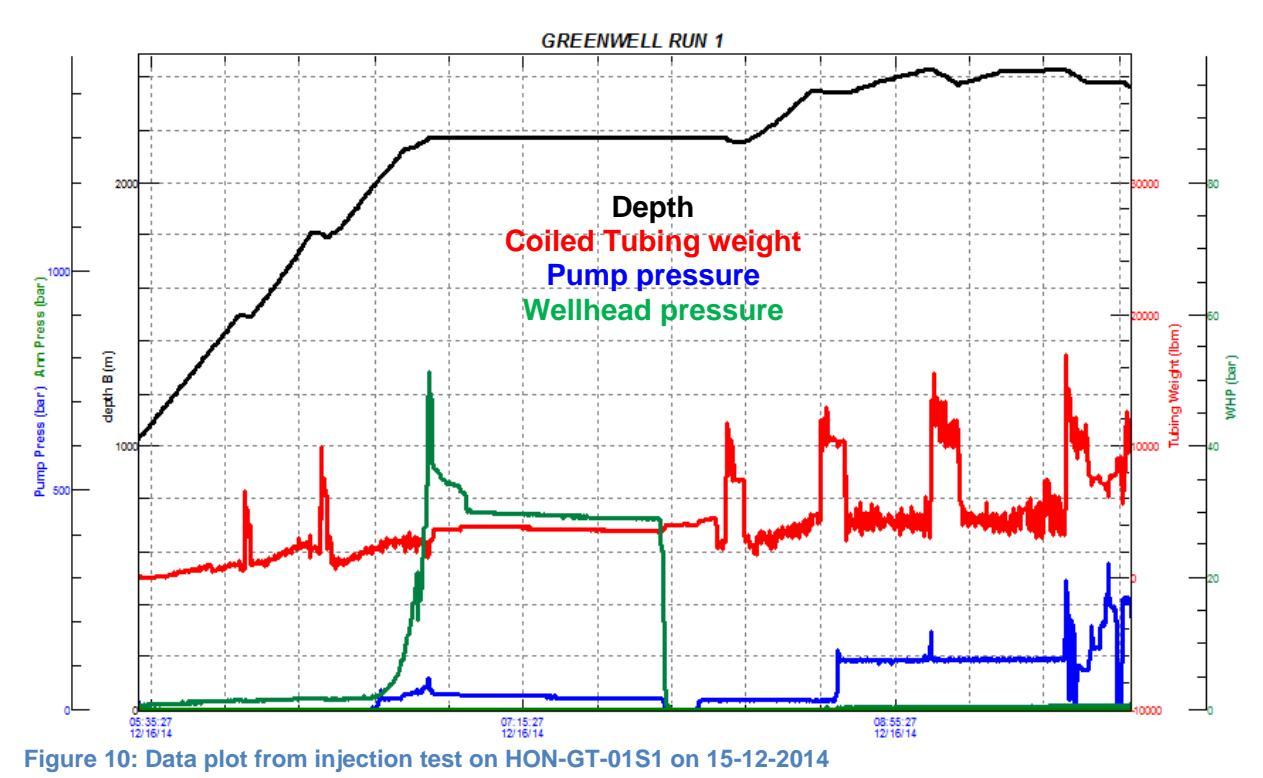
An injection test was performed on the well with water. The pressure was building to 30 bar, after which the pump was stopped. Pressure was monitored for 30mins during which it remained stable (Figure 10).

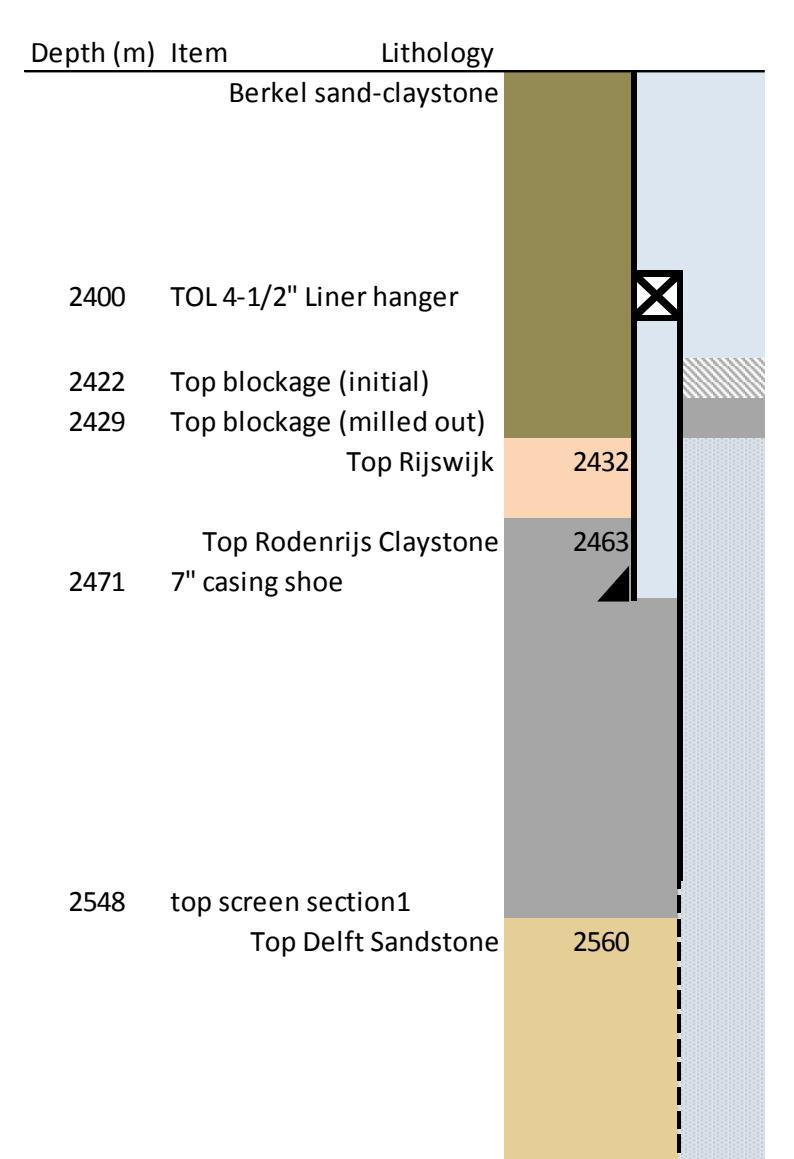
Figure 12: Zoomed in section of well schematic at area of interest (vertically approximately to scale)

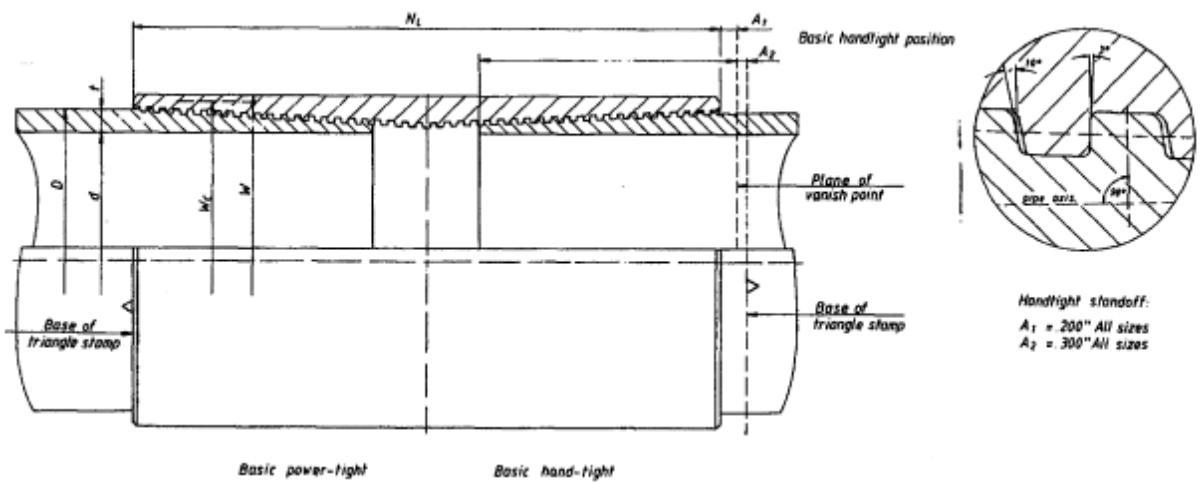
The 4 $\frac{1}{2}$ " production liner has BTC couplings. These leave a small 'open' space between the casing joints. In this space the coupling thread is exposed, which gives both a small ledge and an irregular surface (see Figure 13).

Figure 13: Schematic drawing of a BTC connection (Source: Weatherford Tubular connection data book 1992)

In addition it is recommended to remove edges and uneven surfaces from the inside of the well bore as much as possible. Therefore it is recommended to:
