<u>Green Well Westland</u>

HON-GT-01-S1

Blockage investigation

Prepared by:	WEP
Author:	Kornelius Boersma
Version:	1.4
Publication date:	26 March 2015
Agreed:	Maarten Middelburg, Henny Cornelissen, Dick Swart, Alexander Nagelhout

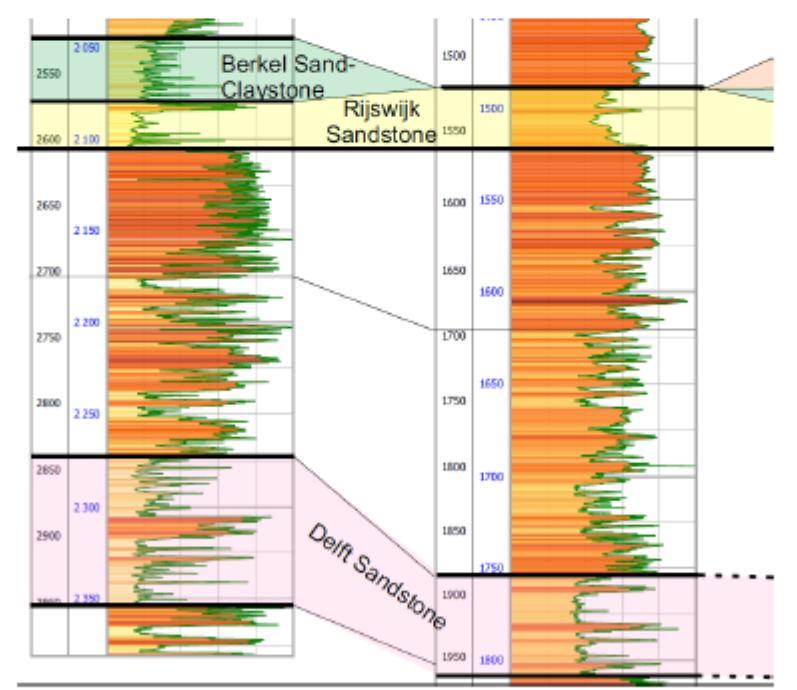
Figuur 1. Twee putten met de Rijswijk- Rodenrijs en Delft. De linker put is PNA-GT-03, de rechter put is VDB-04. De kolom met dieptes in zwart (links) = measured depth AH, in blauw (rechts) is TVD. Het monster van HON-GT-01ST1 komt overeen met wat is gevonden in VDB-04 in het interval tussen de basis van de Rijswijk Sandstone en 1600m AH.

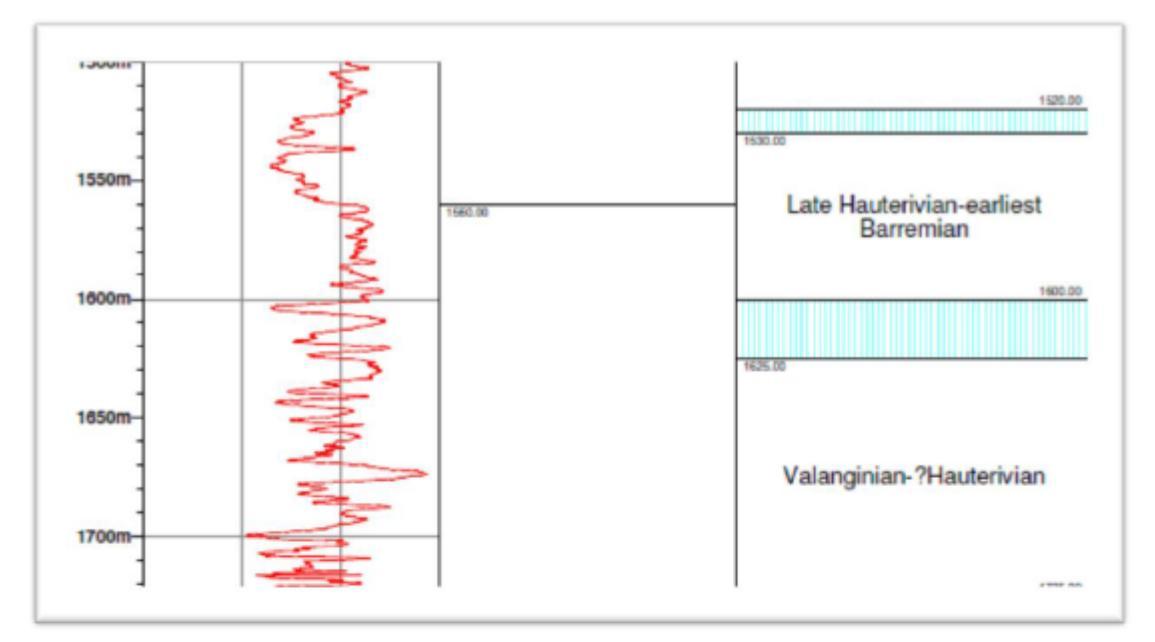
Figuur 2. Gedeelte van de GR log van VDB-04 van de Appendix van Munsterman (2012). De basis van de Rijswijk is hier op 1560 m. Het interval met de gevonden microfossielen is van 1570 tot 1600m.
