END OF WELL REPORT

HON-GT-01-S2

Operator:	Green Well Westland
Prepared by:	Well Engineering Partners Toldijk 17-19 7900 AP Hoogeveen (NL) Tel: +31 (0) 528 227710 www.wellengineering.nl
Author:	S.Kaldenbach, K. Boersma
Version:	1.0
Publication date:	21 August 2015
Reviewed by:	Volkert de Ruiter
Agreed by:	Maarten Middelburg

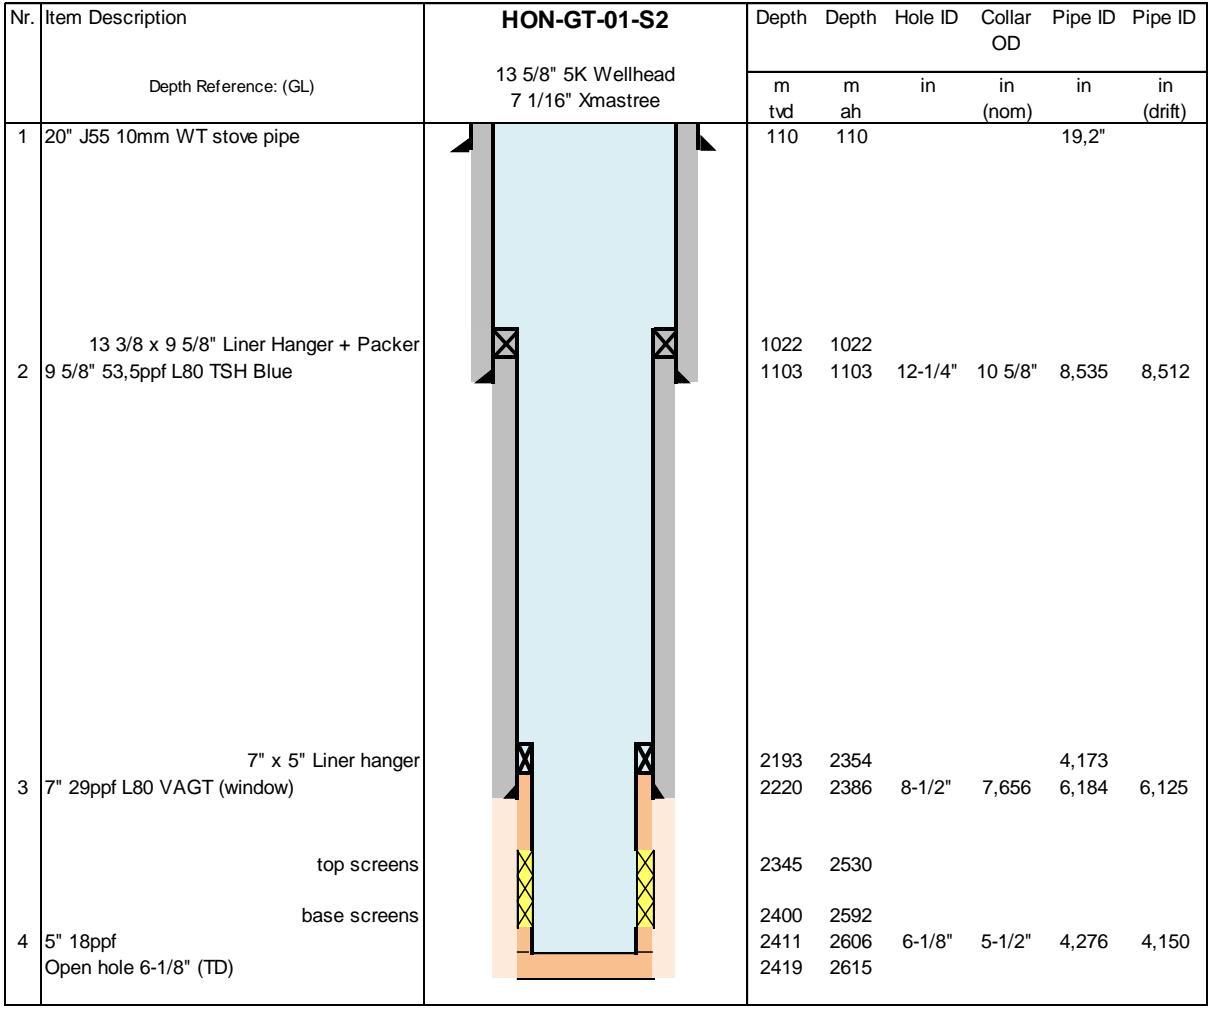
Figure 2: HON-GT-01S2 well schematic

A detailed well schematic summarizing all casing sizes is shown below.

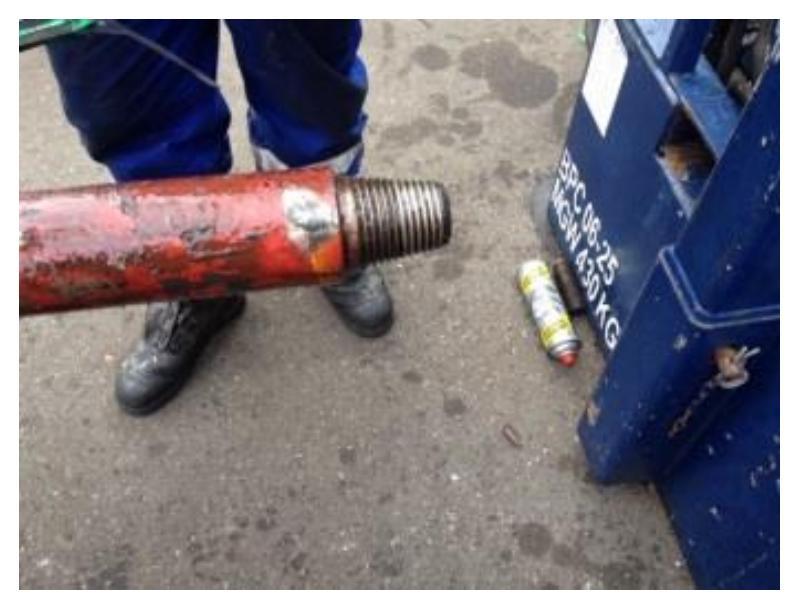
Figure 3: Stripped connection inspected at surface

The liner was latched on in the first attempt and straight pull up to 150mT overpull was applied, without success. Thereafter jarring commenced, and on the seventh jar cycle the BHA came loose, after checking the up weight against the original weight the BHA was POOH. At surface it was observed that the Itco spear and bullnose were lost down hole.

- + Successfully run the fishing BHA combi run with 6-1/8" string mills and non-rotating scraper to the top of the liner (6-1/8" > standard 7" 29# regular drift).
- + All BHA items were retrieved without increased LSA activity.
- Unable to retrieve the liner
- Lost the Itco spear and bullnose down hole

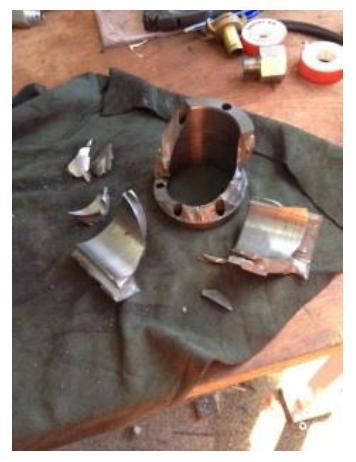
Figure 4: Broken MWD pulser sleeve

The Whipstock was picked up with the laydown winch of the HWO unit and lowered and hung off in the window where the mill assembly was connected and lowered until the MWD carrier collar. During the attempt to load the MWD probe the MWD pulser sleeve got broken and the tungsten carbide pieces were not all retrieved. All BHA components were laid down to check if there were any tungsten carbide pieces had dropped inside the string. Some pieces were retrieved from the mill. The backup sleeve and pulser sub were picked up.

- + Spot on orientation of the Whipstock
- + Good release of the mill and good progress milling steel.
- + Mill's came out and were checked with the "no-go" ring \rightarrow OK.
- Difficulties loading the MWD and time delay due to the broken pulser sleeve

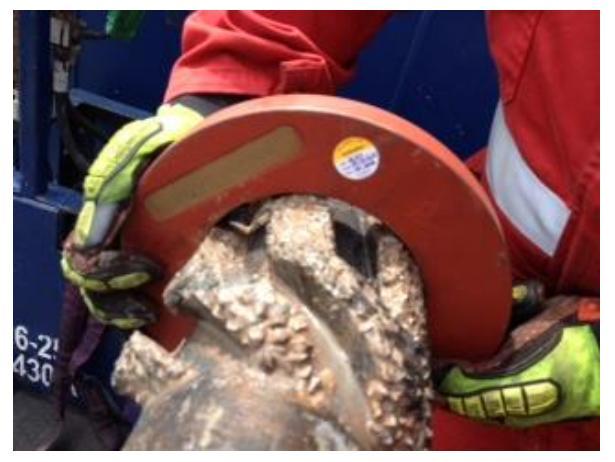
Figure 5: Mill with no-go gauge ring

The return fluid was stored inside two containers (respectively 70m³ and 28m³), including a total of 5m³ mist zone. After the displacement the BHA was POOH and laid down. The mills were found up to spec passing the no-go ring gauge test.

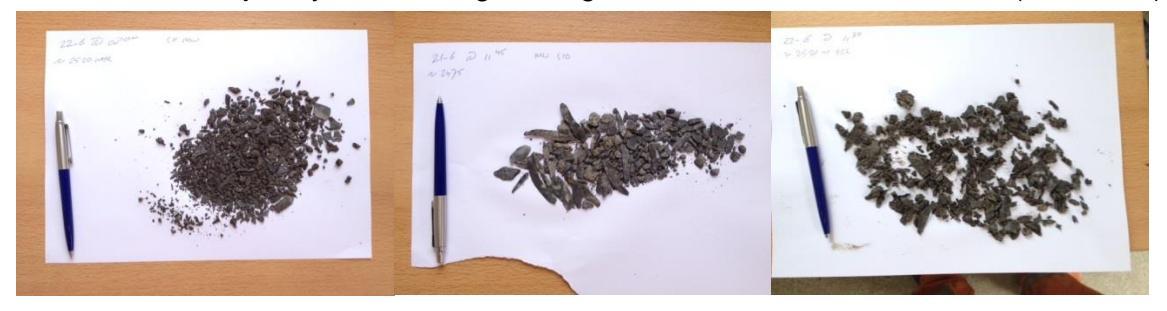
From the Rodenrijs claystone cavings throughout the section were observed (see below).

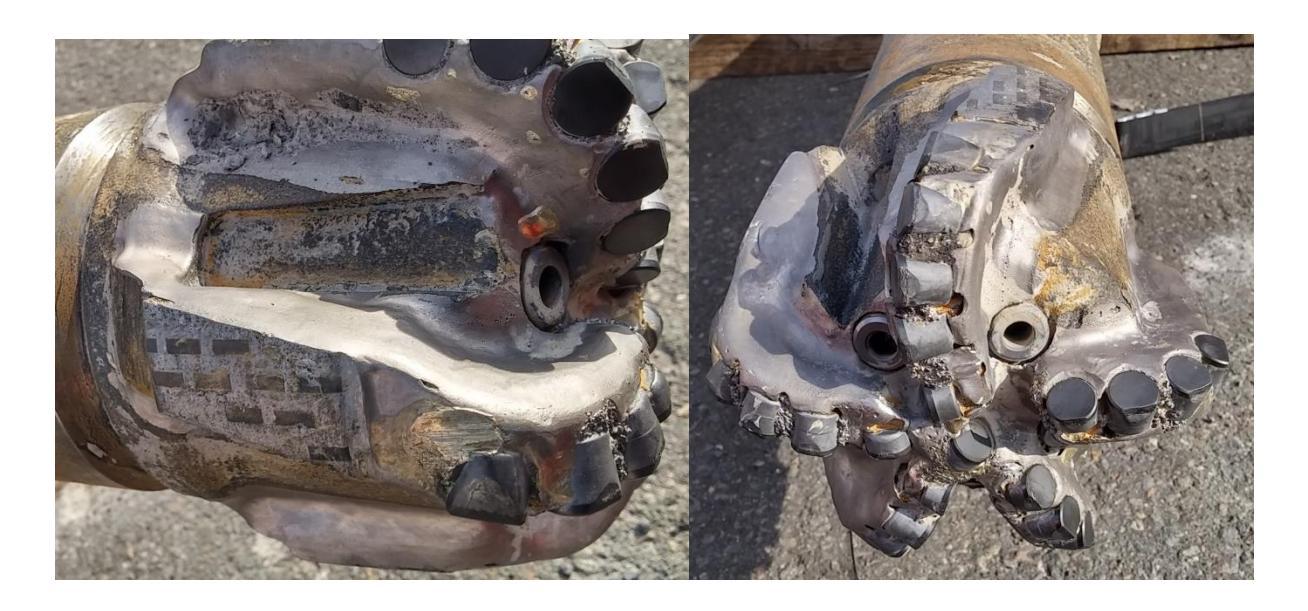
Drilling was continued to 2615m. GR signal was lost after 2578m. Circulated hole clean with 2x B/U. POOH to surface, initial drag on first 2 singles. No further drag was encountered. Laid down BHA and found the bit severely damaged with damaged cutters and washouts on the side. (grading: 6-4-WO-A-X-1-ER-TD), no cutters were missing. PDM shaft/bearing also showed signs of washout.

- + Good departure of the wellbore from the existing well
- + Drill to well TD in single trip
- Two unexpected doglegs of 17.5°/30m 2431m bgl and 9.6°/30m 2450m bgl without the influence of sliding.
- Caving's coming over the shakers since drilling the rodenrijs claystone
- Limited to no ability to treat the mud (no centrifuges and limited screens on site)
- On-bottom ROP significantly lower than forecasted (1,5-2 m/hr vs. 5-12 m/hr)
- Bit severely damaged/worn & 1/16" undergauge. Washed out.
- PDM shaft/bearing showed signs of washout
- Lost GR signal while drilling from 2578m to 2615m

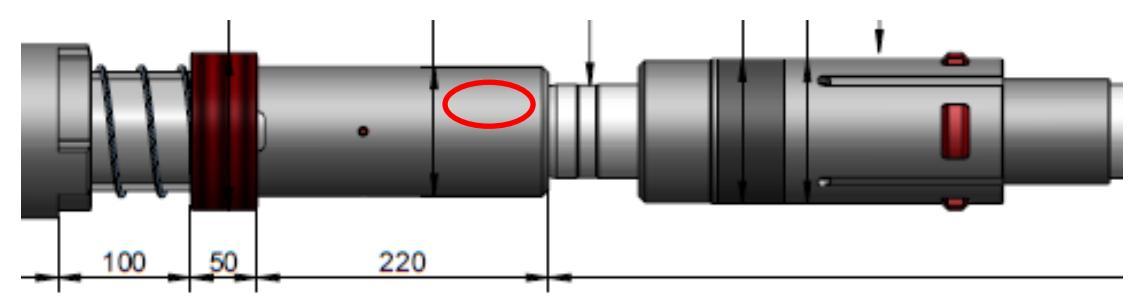
Figure 6: Planned location of perforations (inside red circle)

While retrieving the liner hanger setting tool the tool could not be retrieved. There was ca. 1,5m free travel and rotation could be achieved. Due to the setting of the packer circulation was not possible. On wireline a free-point indicator was run, which found the free-point 4m above the TOL. From these observations it was expected that the situation was caused by hole fill – sands from the displacement which had now settled above the top of the liner.

2 perforations were then made just above the liner hanger to allow circulation to attempt to loosen the sediment to allow the setting tool to be retrieved. These perforations were placed successfully at exactly the planned location.

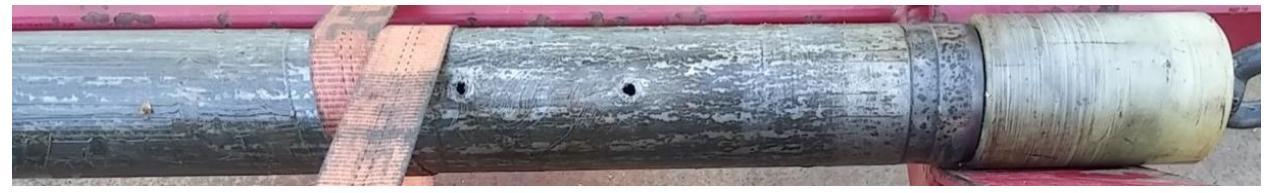
Figure 7: Perforations after POOH

Circulation could be achieved and the first two joints were washed out. Thereafter POOH the string successfully without further circulation.

- + Successful screen placement to TD
- + Perforations successful to retrieve setting tool
- Unable to retrieve setting tool, required to perforate tool to allow circulation
- 2jnts inner string (out of 40) did not pass drift due to damage at tool joint
